# Post Sterilization Lab Contamination

**PDA Midwest May 2018**

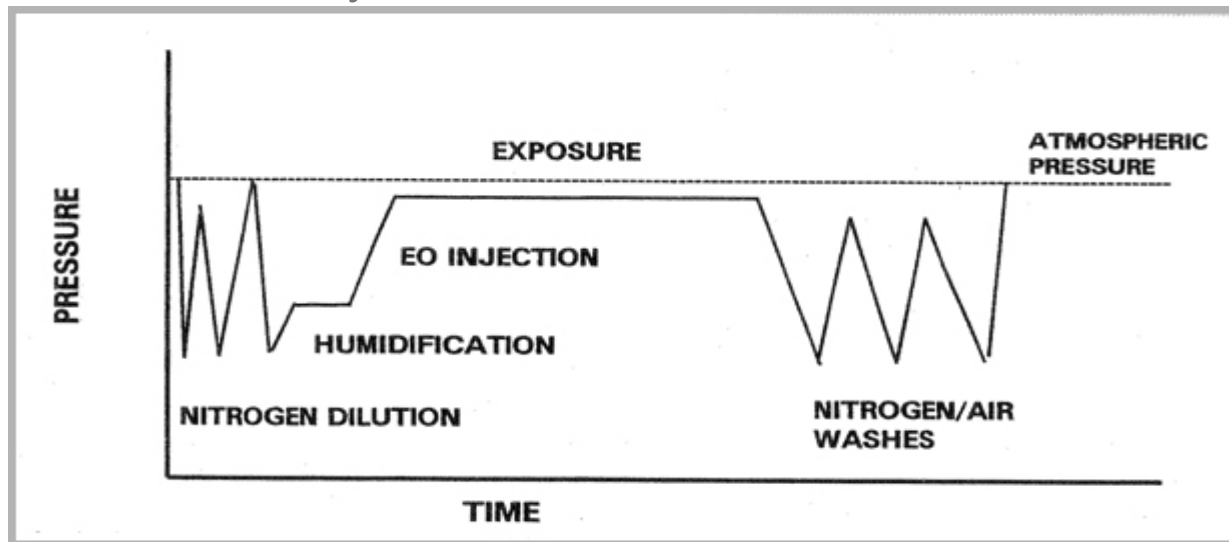
3 stages of process:

2. Sterilization Cycle

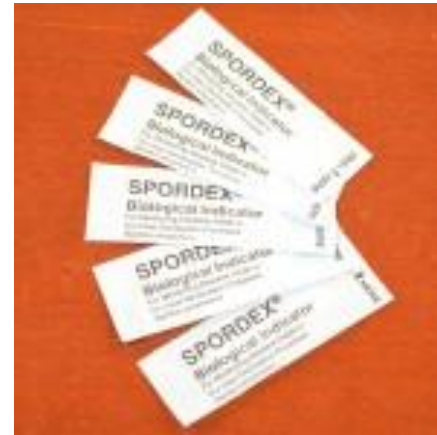
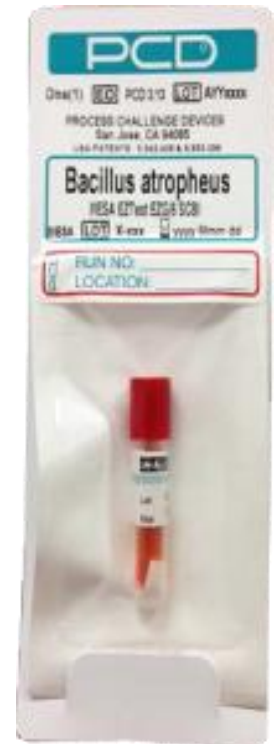
- > Spore strip with  $10^6$  CFU of *Bacillus atrophaeus* (*B. subtilis var niger*)
  - Spore-forming organism, growth has distinctive orange color
  - Analog for *B. anthracis* in US bioweapons program
- > Internal PCDs placed inside challenge product in load in most difficult to sterilize location
  - Create a challenge for migration of gas into product
- > External
  - Placed on outside of product load
  - More resistant to sterilization than internal PCDs

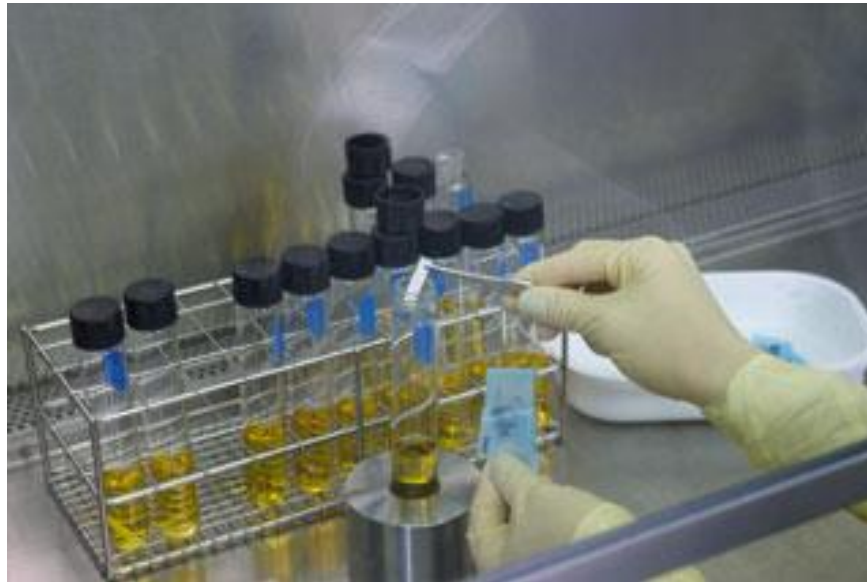
- > Necessary for product release when not utilizing parametric release
- > Remove External PCD from product prior to aeration
  - Ensure worst-case in terms of exposure to EtO
- > Aseptically transfer to a culture media (Tryptic Soy Broth)
- > Incubate 30 - 35°C for seven days
